## TECHNICAL BUILD DETAIL 996.1.3

Vehicles Impacted: Porsche 996 Carrera 2 & Carrera 4

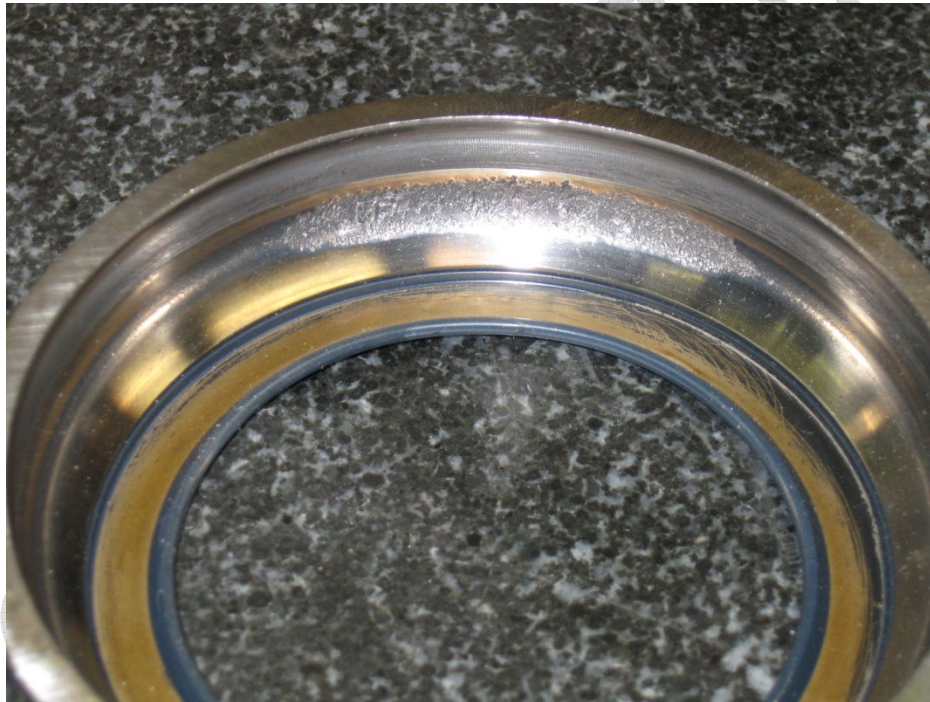
Pinion shaft or main shaft bearing failure in the 996 series transaxles can lead to severe damage of the gear sets, shafts, and casings of the gearbox. For this reason Gbox fully inspects all of the bearings in the gearbox and replaces those found to be damaged. The example below shows a pinion bearing with a type of surface failure known as spawling. The phenomenon of spawling is analogous to a pothole in the road. As the tire or ball bearing rolls over the road or raceway and encounters a surface defect large impact loads develop which expand the size of the pothole or spawl. This condition leads to rapid degradation of the bearing.
