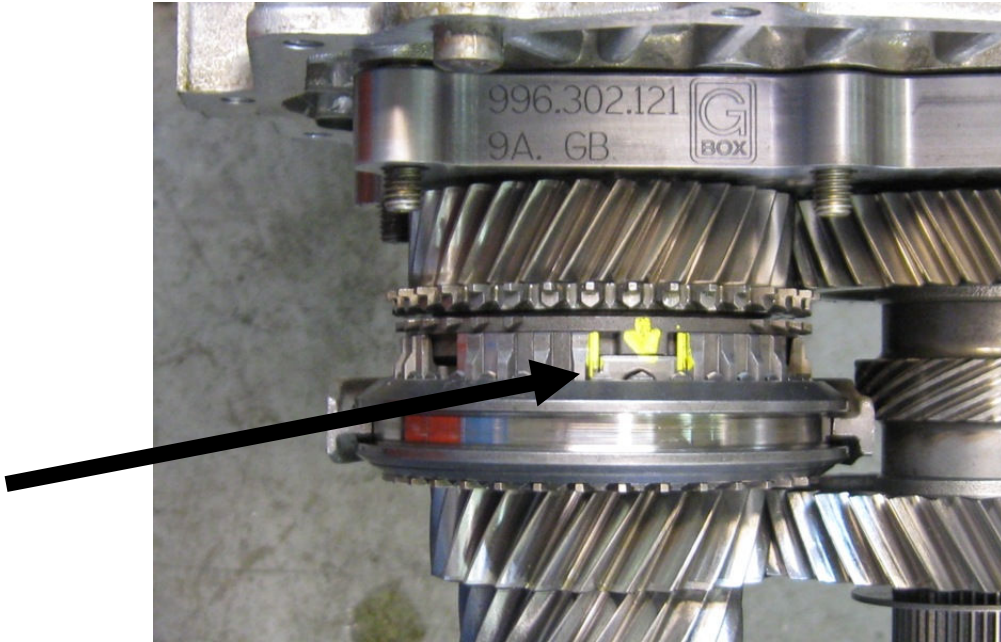
Syncro ring in correct window

The index tab on the syncro ring MUST be installed against the pressure block in the shift hub (see photo). Failure to install the syncro ring correctly will cause grinding and require gearbox disassembly to correct.
