## TECHNICAL BUILD DETAIL 996.1.5

Vehicles Impacted: Porsche 996 Carrera 2 & Carrera 4

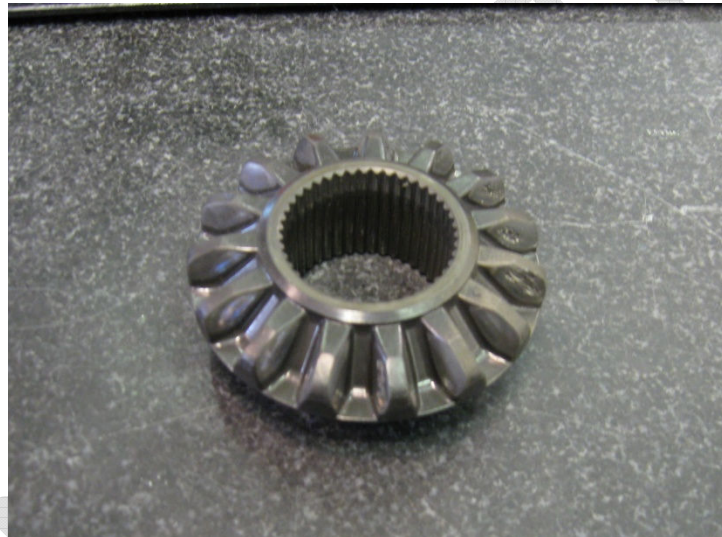
Differential spider gears with surface defects like those shown below have the potential to lead to severe transmission damage and even loss of vehicle control. As the spider gear continues to degrade small chunks of hardened metal will be introduced to the rest of the transmission. These chunks will result in damage to other components. If one of these chunks were to get stuck between the gear teeth the differential could lock resulting in a rear axle skid. Gbox carefully inspects differential spider gears and other differential components during disassembly and cleaning to make sure these are in top condition.
