## TECHNICAL BUILD DETAIL 996.1.2

Vehicles Impacted: Porsche 996 Carrera 2 & Carrera 4

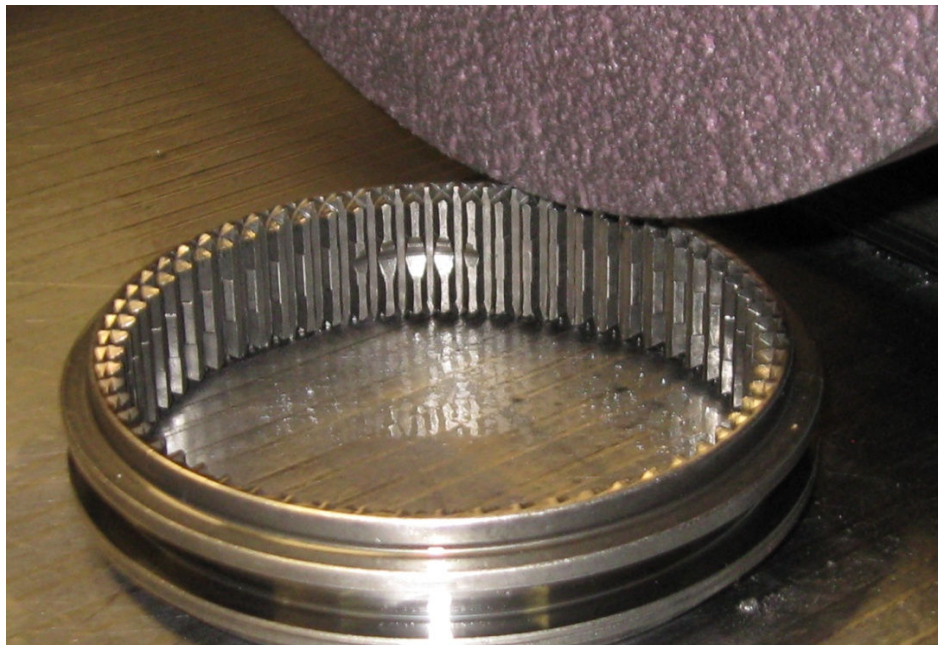
In order to assure that every gearbox we service shifts perfectly, Gbox uses a special in house surface grinding technique for the 1<sup>st</sup> and 2<sup>nd</sup> gear shift sleeve. Grinding the shift sleeve allows the teeth to engage the gear further thus allowing the back cut on the teeth to hold the slider in gear much more firmly. This is just one of the unique blueprinting techniques used by Gbox to cure “popping out of gear” problems.
